**THE TENNESSEE VALLEY
AUTHORITY'S KINGSTON ASH SLIDE:
EVALUATION OF POTENTIAL
CAUSES AND
UPDATES ON CLEANUP EFFORTS**

HEARING
BEFORE THE
SUBCOMMITTEE ON
WATER RESOURCES AND ENVIRONMENT
OF THE
COMMITTEE ON
TRANSPORTATION AND
INFRASTRUCTURE
HOUSE OF REPRESENTATIVES
ONE HUNDRED ELEVENTH CONGRESS
FIRST SESSION

JULY 28, 2009

REVIEW OF THE KINGSTON FOSSIL PLANT ASH SPILL ROOT CAUSE STUDY AND OBSERVATIONS ABOUT ASH MANAGEMENT

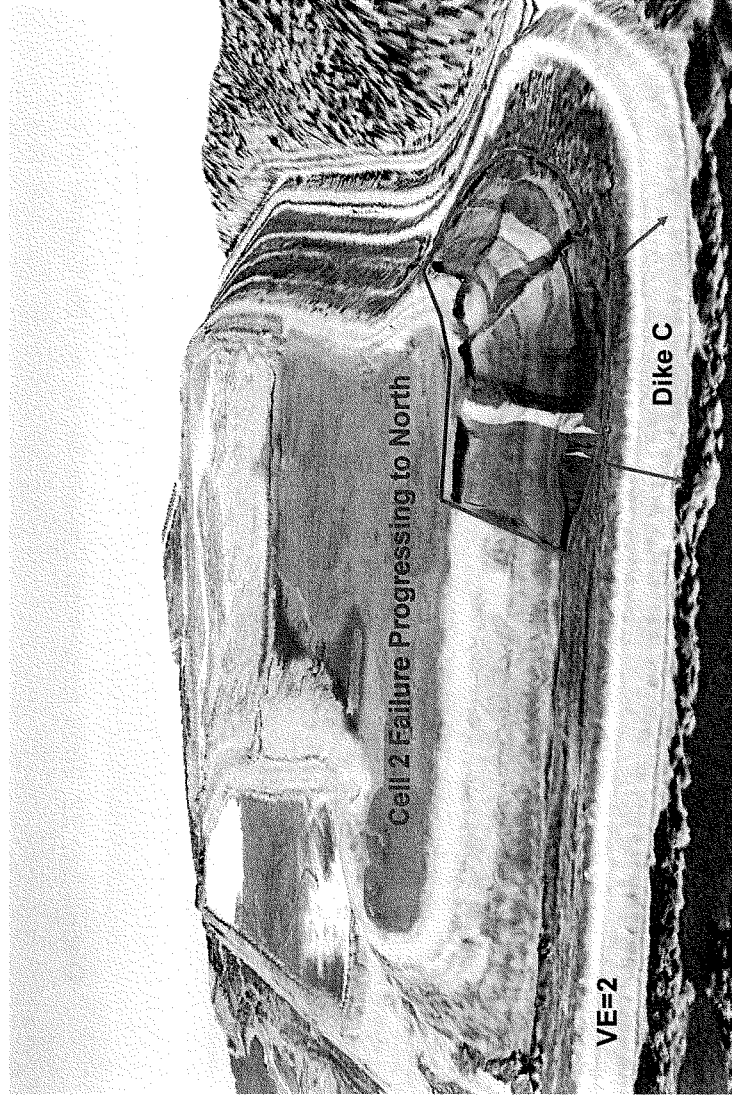
Figure ES_8

December 22, 2008 Expected Failure Mode at NW Corner of Cell 2

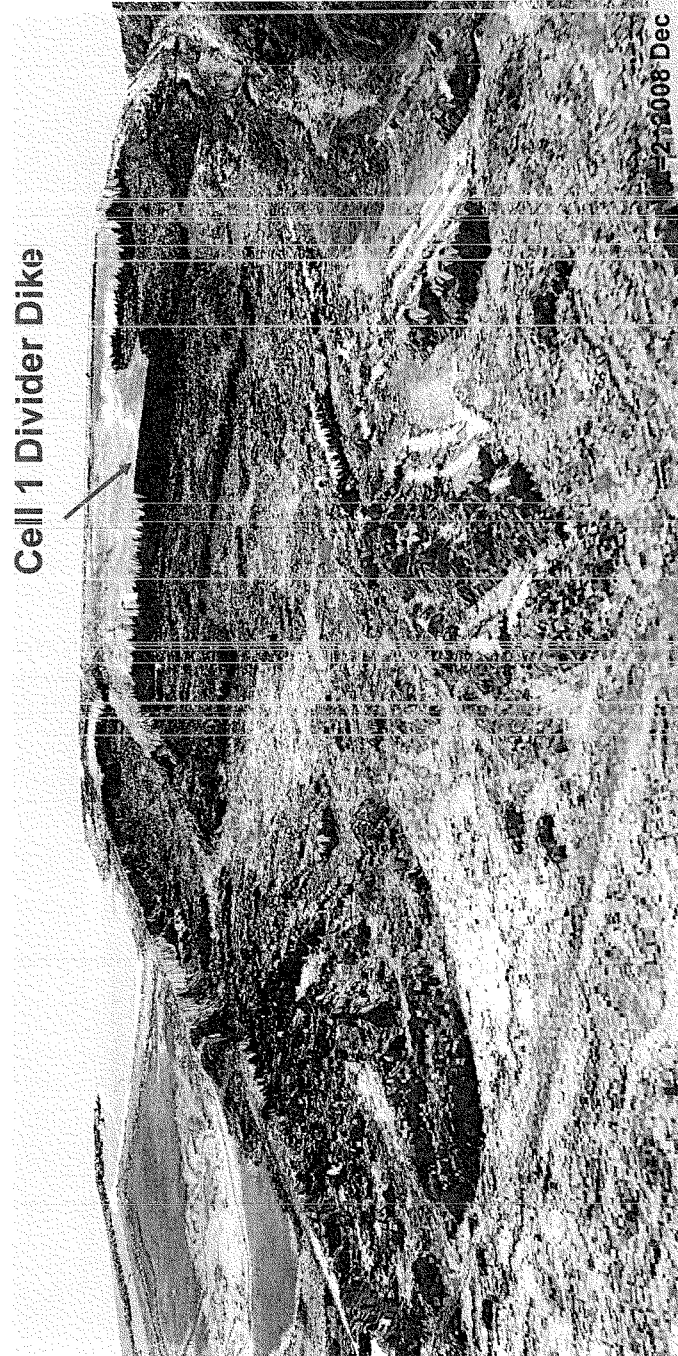
Figure ES_11

December 23, 2008 Post Failure Photo Overlay on TVA Surveys

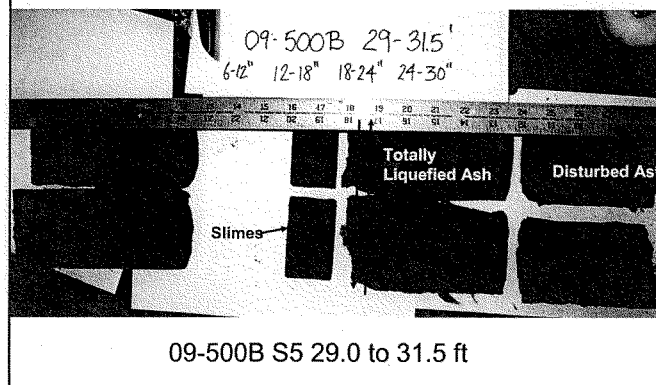
Clay/Laminated Slimes/Failed Ash
at 09-500B, OST5
